AZ100 multizoom microscope helps Joe Gibbs Racing drive for the checkered flag

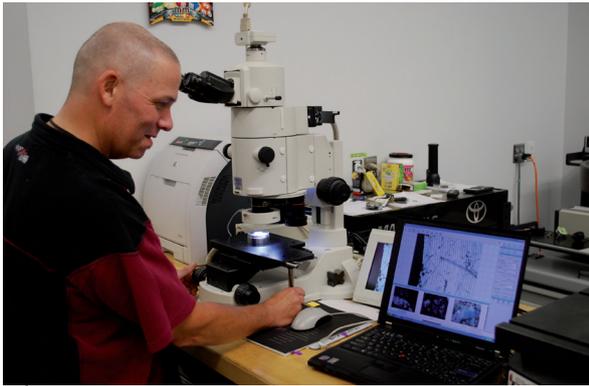
In the early part of 2010, the JGR engineers were facing a problem. The racecar engine's rocker arms – reciprocating levers that convey radial movement from the cam lobe into linear movement at the poppet valve, and are responsible for helping the cars accelerate to their incredible speeds without blowing the engine – were experiencing excessive wear and tear, even though they were coated with lubricants to

prevent just that type of damage. With their available tools, the JGR engineers could not see how or why the damage was occurring, so they contacted Nikon Metrology to see if they could help solve the issue.

Through video conferencing and image sharing, it only took the two groups 90 minutes to determine that inclusion and discoloration in the coating were responsible for the rocker arms’ damage – and that the excessive stress and heat placed on these parts were not being properly deflected. Immediately, the vendor/technical partner engineers were able to propose a solution to the problem, whereas with the previous system it would have taken anywhere from two
